FELLOWS LAKE DAM

GREENE COUNTY, MISSOURI

MO 20036

**PHASE 1 INSPECTION REPORT  
NATIONAL DAM SAFETY PROGRAM**

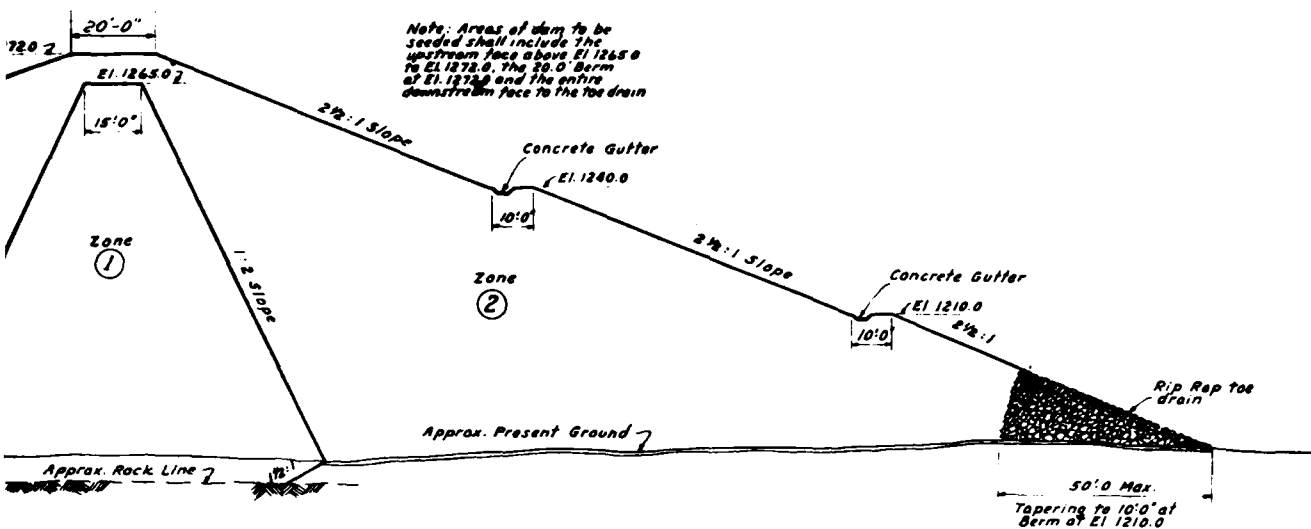
L SECTION THRU DAM  
Scale 1" = 20'

The history of high phreatic surface occurrences near the berm at elevation 1210 but relatively lower concurrent observations downslope suggest the "Rip Rap Toe Drain" shown on Plate 5 to be functioning as intended. The description of this toe drain in the contract specifications is incomplete to be considered a "graded filter" by current understanding. More should be known about the material gradations and if there is zoning of different size materials. This lack of information is considered a deficiency related to the seepage analysis.
